MEXICO WATER STORAGE TANK

Project Location
Mexico, Missouri

Project Completion Date
November 2005

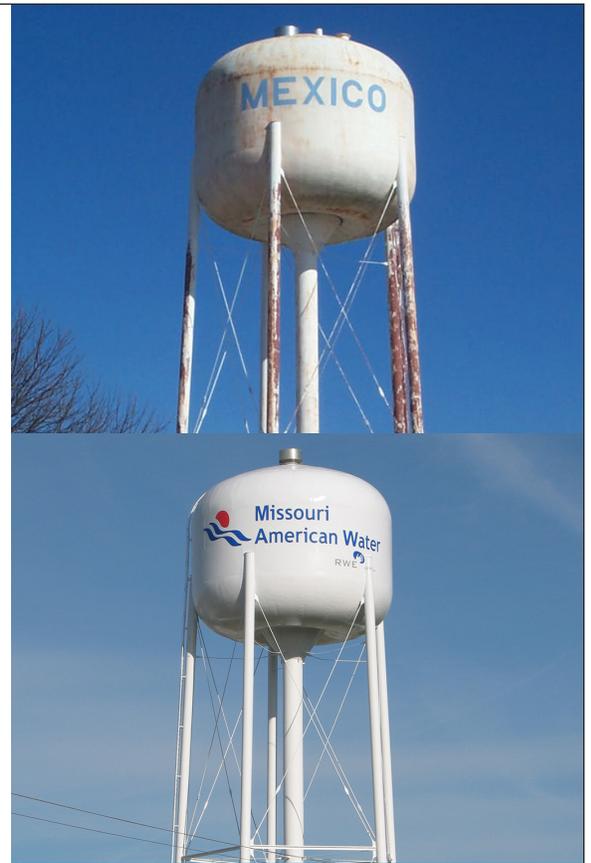
U.S. Senator from Missouri Kit Bond remarked on the improved appearance of the water tank in Mexico, Mo., after it was coated with Series 700 HydroFlon in late 2005.

The applicator spray-applied a prime coat of Series 91-H₂O Hydro-Zinc, a two-component, moisture-cured zinc-rich aromatic urethane, on both interior and exterior steel. The first organic zinc-rich primer to be ANSI/NSF Std. 61 certified, Hydro-Zinc offers superior bonding to steel surfaces that are abrasive-blast cleaned in accordance with SSPC-SP10 for tank interiors and SSPC-SP6 Commercial Blast Cleaning for exteriors. The prime coat was followed by two interior coats of Series 20 Pota-Pox, a polyamide epoxy, at 4.0 to 6.0 mils DFT each. On the exterior, a coat of Series 73 Endura-Shield, an aliphatic acrylic urethane, was roller-applied at 2.0 to 4.0 mils DFT. The HydroFlon finish coat was roller-applied at 2.0 to 3.0 mils DFT.
