# OAKRIDGE WATER TANKS

## FEATURED PRODUCTS

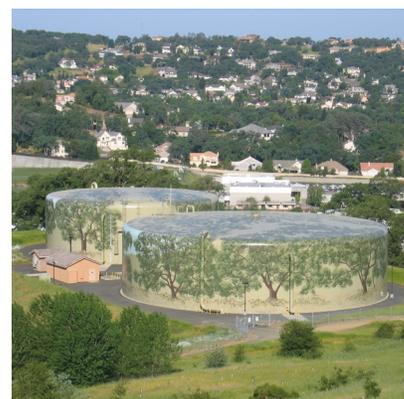
Murals were painted on the Oakridge water tanks in Placerville, Calif., with the same aliphatic acrylic polyurethane coating used as an overcoat on both tanks.

The murals were painted using the same high-performance, semi-gloss aliphatic acrylic polyurethane (Endura-Shield II) coating used as an overcoat on both tanks. "We use exactly the same paint as the base coating on the tanks – just different colors," Hennig noted. "We try to promote Tnemec coatings in all our projects because they wear so well and don't fade. There are tanks that we've done 15 years ago that still look wonderful."

Prior to construction, the interior and exterior steel plates of the new 5.0 MMG capacity tank were shop-primed with Series N140 Pota-Pox Plus, a polyamidoamine epoxy, at 3 to 5 mils DFT. The tank interior was finished in the field with two coats of Series N140, and the exterior was finished with one coat of Series N140 plus a topcoat of Series 1075, an aliphatic acrylic polyurethane. The interior was airless sprayed and exterior was roller-applied. The existing 3.0 MMG capacity tank was power-washed on the exterior before it was overcoated.
